NRL Report 6698

**Subcritical Flaw Growth in 9Ni-4Co-0.25C
Steel - A Fatigue and Fractographic
Investigation and Its Relationship to
Plane Strain Fracture Toughness**

T. W. CROOKER, L. A. COOLEY, E. A. LANGE, AND C. N. FREED

**NAVAL RESEARCH LABORATORY
Washington, D.C.**

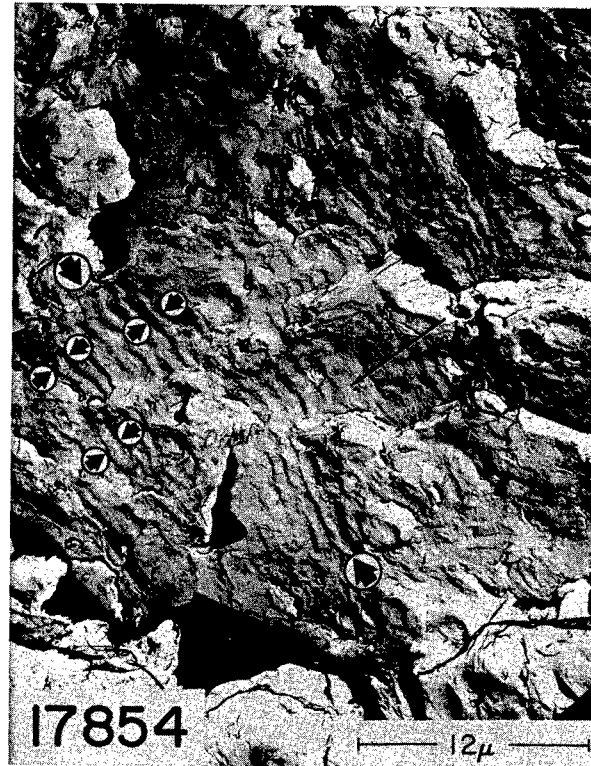
Fig. 9 - Tension-to-tension fatigue markings in a specimen loaded from 250 to 1750 lb. A packet of striations is shown between the large arrows while individual striations appear between the small arrows.

The first region studied encompasses the first 0.1 in. of crack growth, where $a = 0.50$ in. and $\Delta K = 36$ ksi $\sqrt{\text{in}}$. Figures 9 and 10 are from the specimen loaded 250 to 1750 lb. The ruptured surface consists of broad, shallow striations (between the small arrows in

Fig. 9) or tongues and ridges as seen in Fig. 10. The broad, shallow striations comprised 40 to 60 percent of the surface examined. At higher magnifications (Fig. 11) fatigue striations in the specimen loaded 500 to 2000 lb are broad and shallow with the edges of the individual striations outlined by discontinuous tongues. A further illustration of the surface complexity in this region is shown in Fig. 12. Shallow striations appear in the upper left, with shallow, equiaxed dimples in the lower left portions of the fractograph.

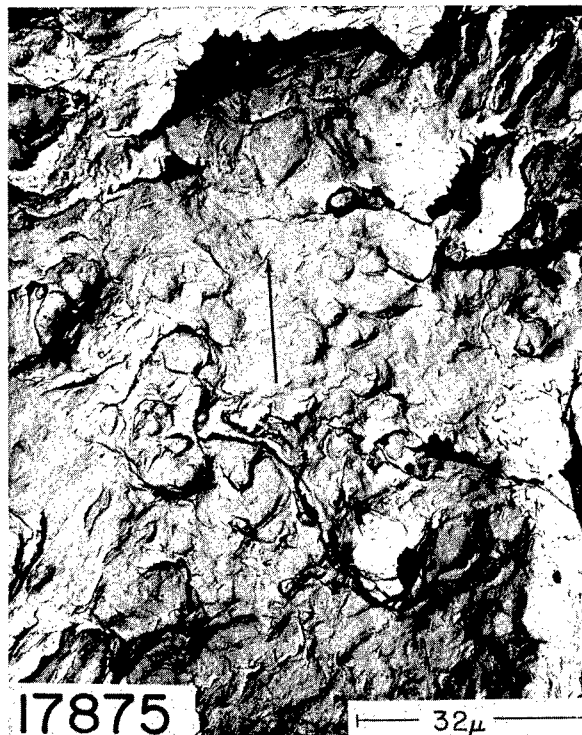
Fig. 13 - Tension-to-tension fatigue markings in a specimen loaded from 250 to 1750 lb. The surface consists of shallow dimples and tear ridges orientated in a random fashion to the fracture path.

As the crack front advances to the second area studied, the broad, shallow striations disappear. For flaw sizes ranging from 0.7 to 0.9 in., the surface of the specimen loaded 250 to 1750 lb consists of shallow dimples and random tear ridges as in Fig. 13 or shallow, equiaxed dimples as in Fig. 14. These features comprised approximately 80 percent of the areas examined.

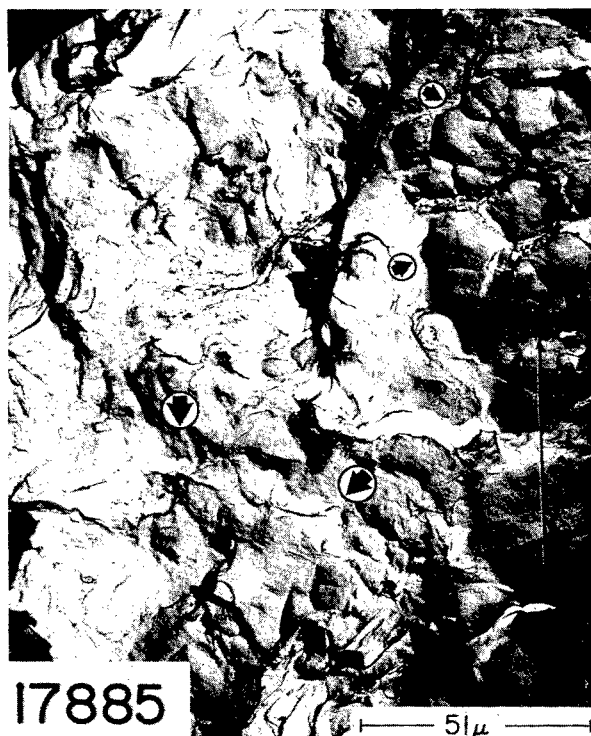
Fig. 14 - Tension-to-tension fatigue markings in a specimen loaded from 250 to 1750 lb. The surface consists of shallow dimples.

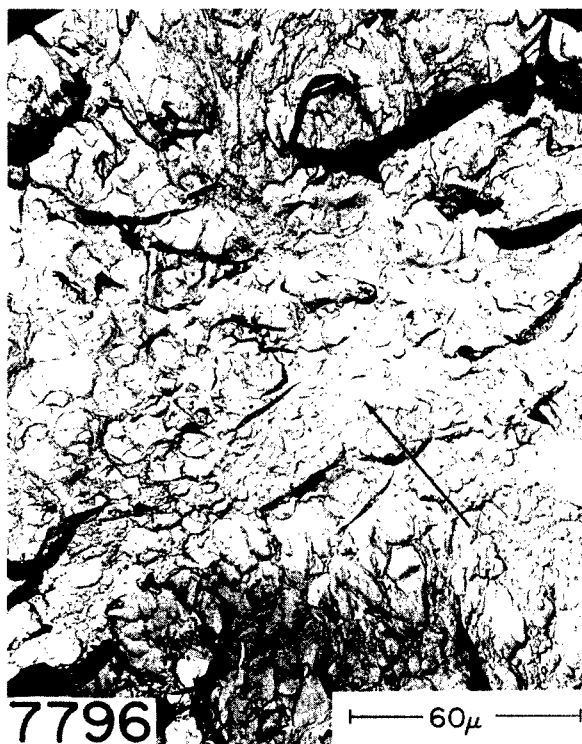
Fig. 16 - Region of fast fracture for a specimen loaded from 500 to 2000 lb. The surface consists of large and small dimples.

The final area studied lies within the region of fast, terminal fracture. The separation consists exclusively of dimpled rupture. Figure 16 illustrates this feature obtained from the specimen loaded 500 to 2000 lb. The microfracture mode is dimpled rupture with no single dimple size predominating.
